# Megger<sup>®</sup>

## Benefits of 1 Hz tan $\delta$ testing for Insulation Condition Assessment

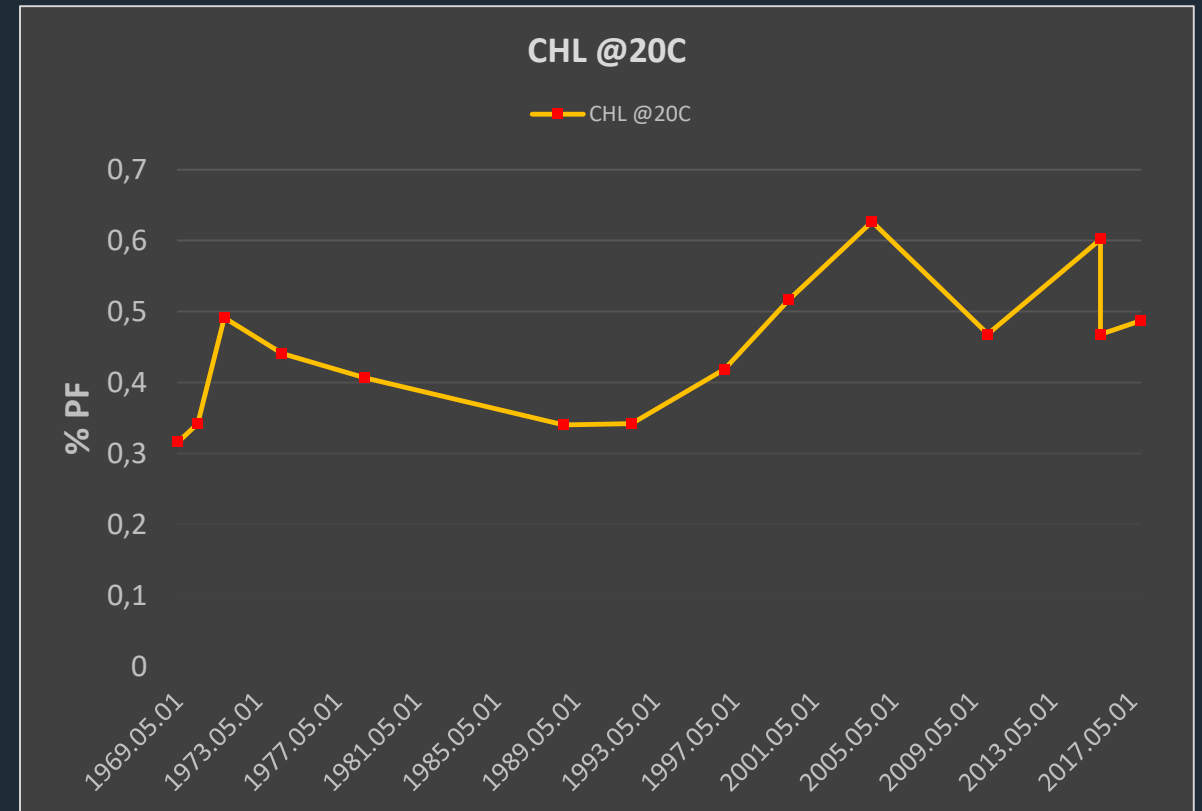
# Line Frequency $\tan \delta$

- Performed at 50 Hz or 60 Hz
- Evaluate @ 20°C
  - Correct with tables
  - Limits set by standards
- Analysis improves with trending
  - Small PF increments not conclusive
- Early deterioration not noticeable

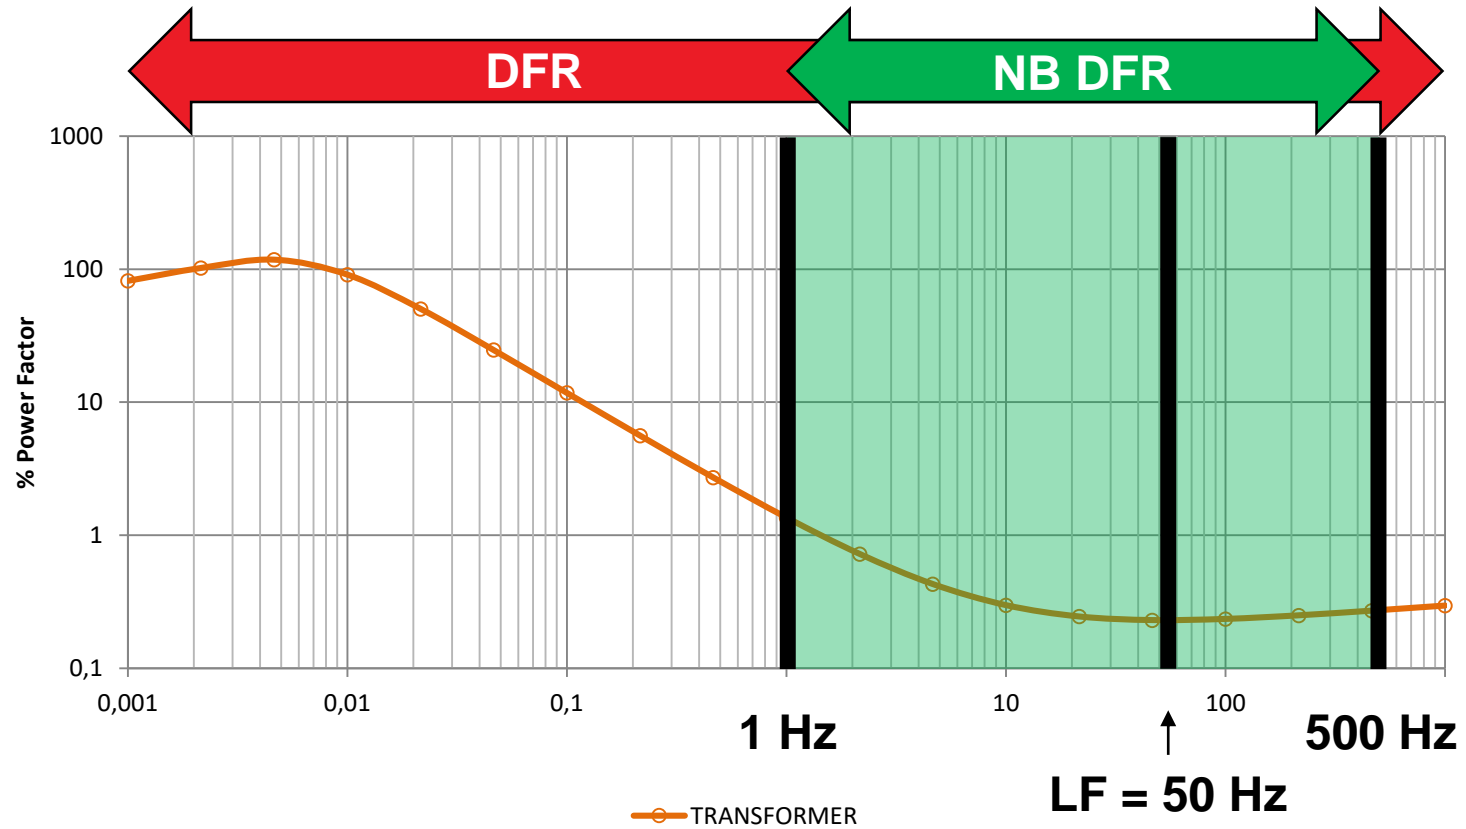
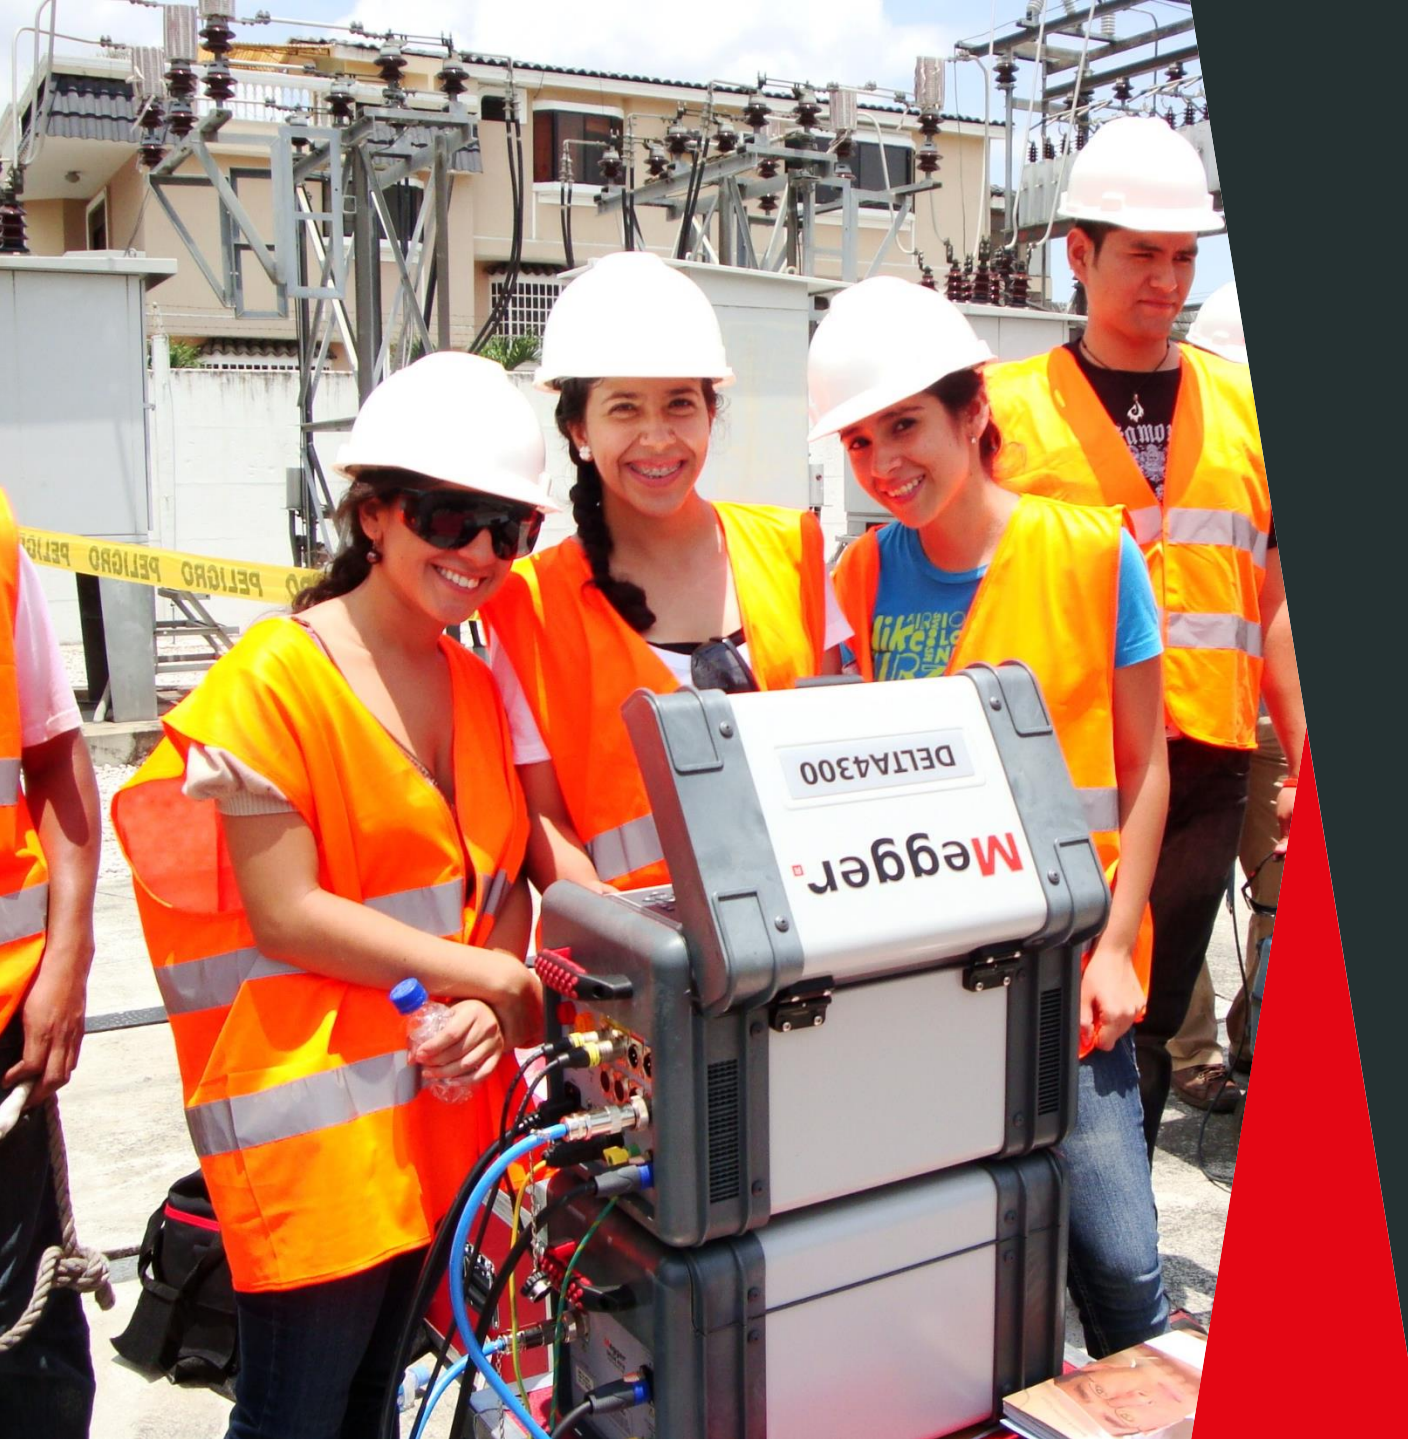
# LF vs NB DFR vs DFR Range

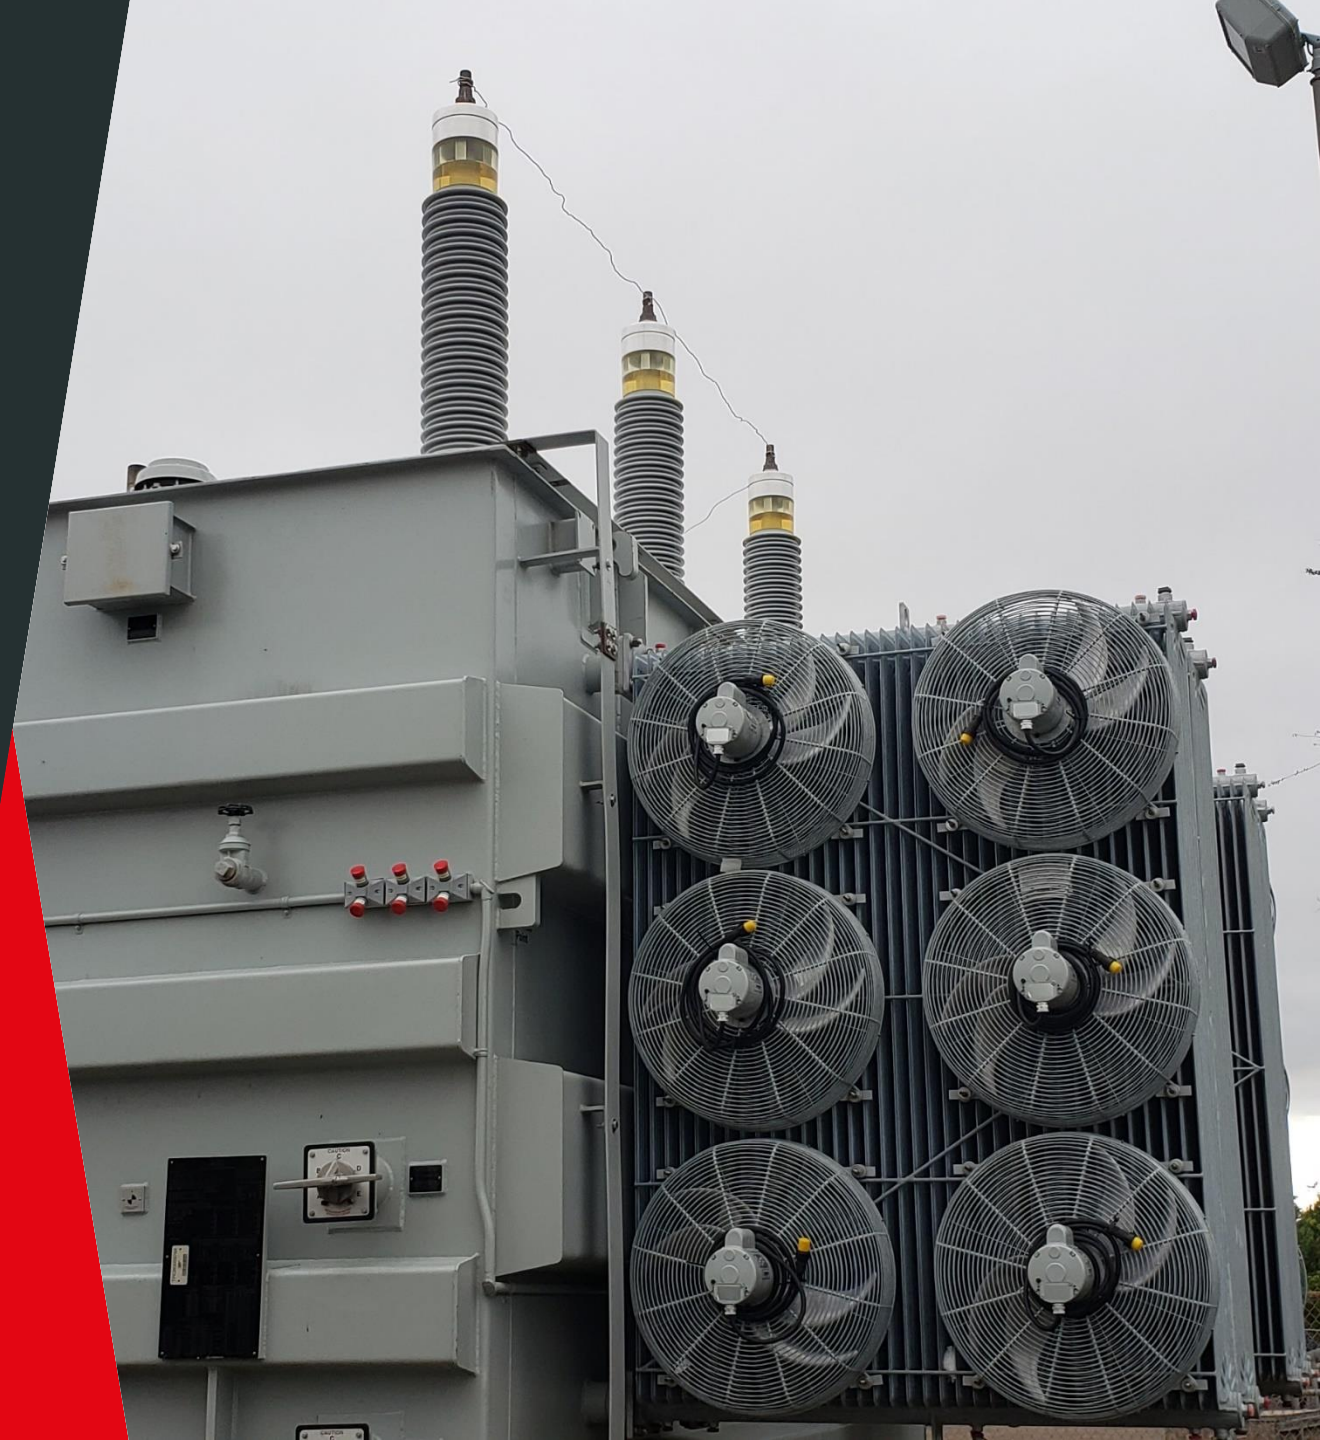
# 2019 16 MVA 138 kV Transformer @ 25°C

- Excellent LF tan  $\delta$  for a new transformer
- ...but 1 Hz looks a little high

# 2019 16 MVA 138 kV Transformer @ 25°C

- With ITC, 1 Hz insulation is rated as aged
- ...but this is a new transformer that has never been in service?!

## ■ C<sub>HL</sub> DFR:

## ■ 1.6% moisture

- High for new transformer that has not been in service

## ■ Oil conductivity of 1.3 pS/m

- also high for new transformer
