Electrical and acoustical PD measurement on a 300 MVA Transformer

21st Conference on High Voltage Insulation Diagnostics, Sopron, Hungary, May 4th, 2023

▶ Case Study – Power Transformer

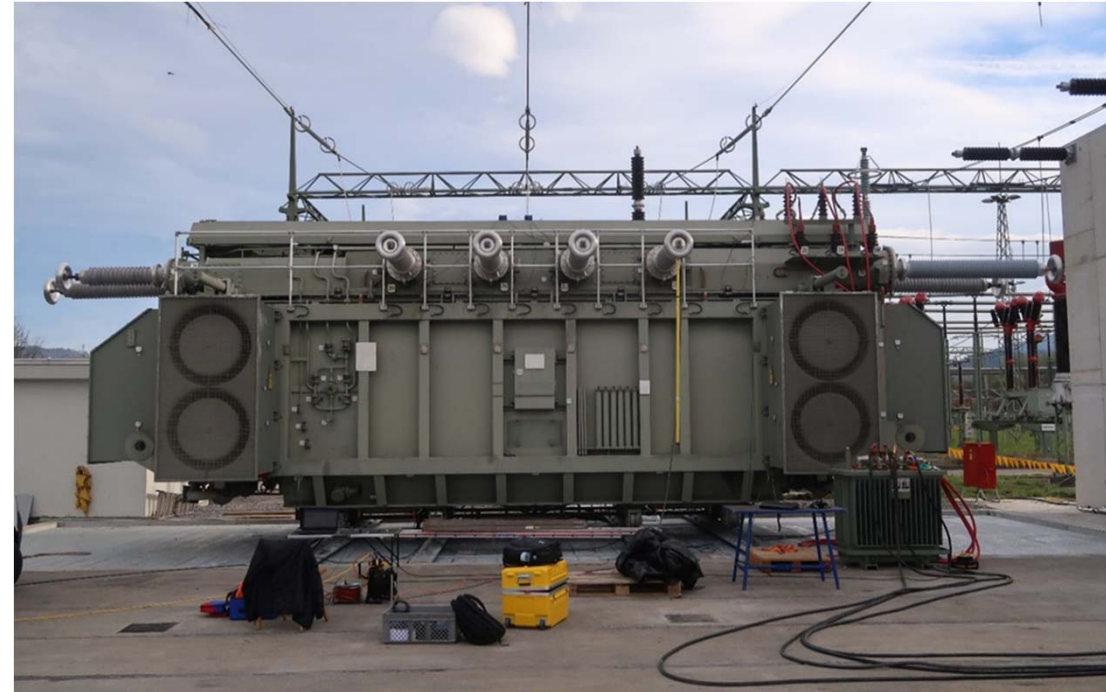
▶ Power Transformer – Offline MPD 800 Test Setup

▶ Power Transformer

- ▶ 220 / 110 / 21 kV
- ▶ 300 MVA
- ▶ YNyn0d5
- ▶ Manufacturing year: 1993

▶ Test Setup

- ▶ Induced voltage test via tertiary winding using a Diesel generator and a step-up transformer
- ▶ PD signals measured at bushing taps on HV and MV windings
- ▶ Setup using 4 x MPD 800 units (8 measurement channels)

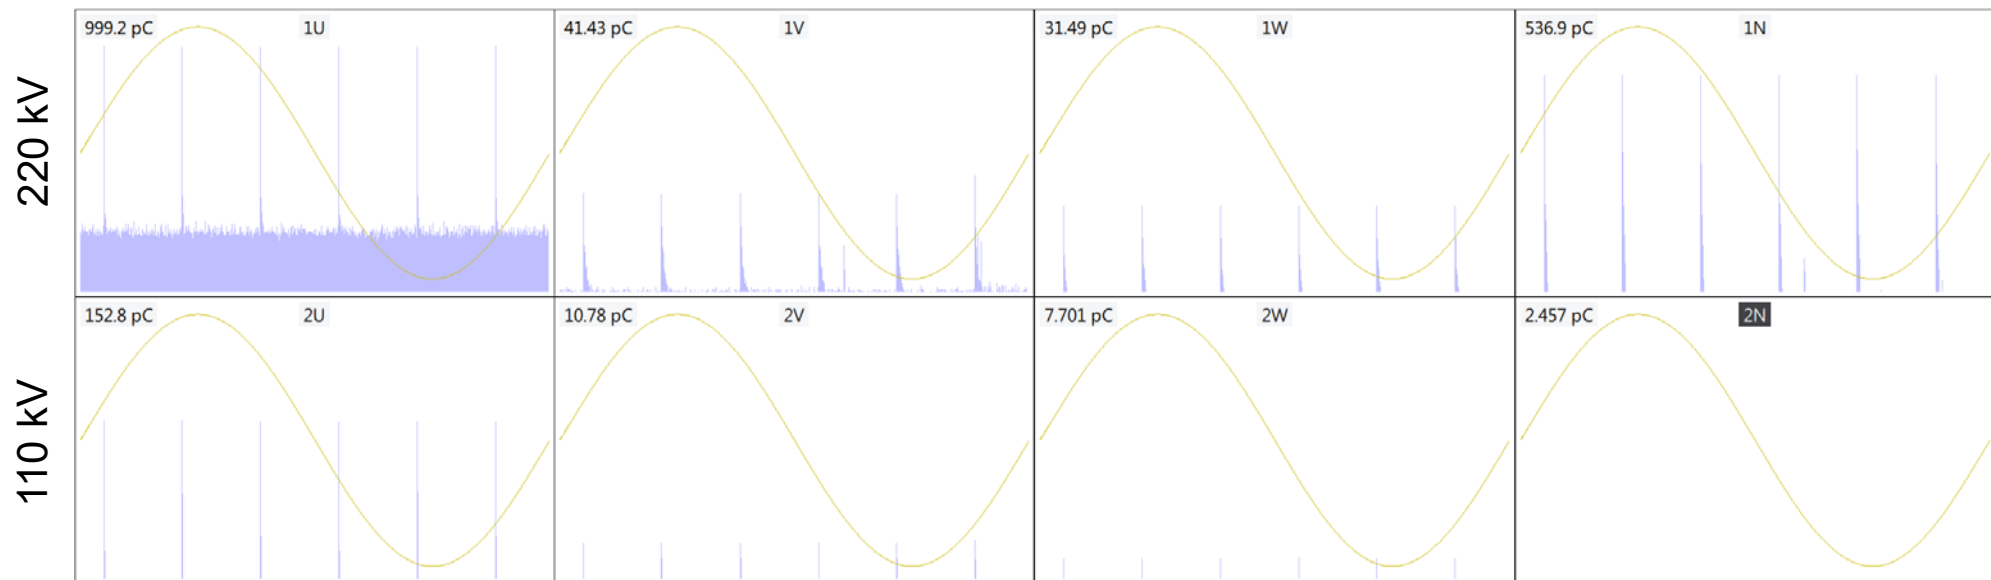
Power Transformer – Calibration

- ▶ Measurement frequency according IEC 60270
 - ▶ $f_c = 400 \text{ kHz}$, $\Delta f = 600 \text{ kHz}$
- ▶ PD Calibration matrix
- ▶ Voltage calibration
 - ▶ Sufficient to enter bushing C1 capacitance to compute test voltage level

Calibration Matrix

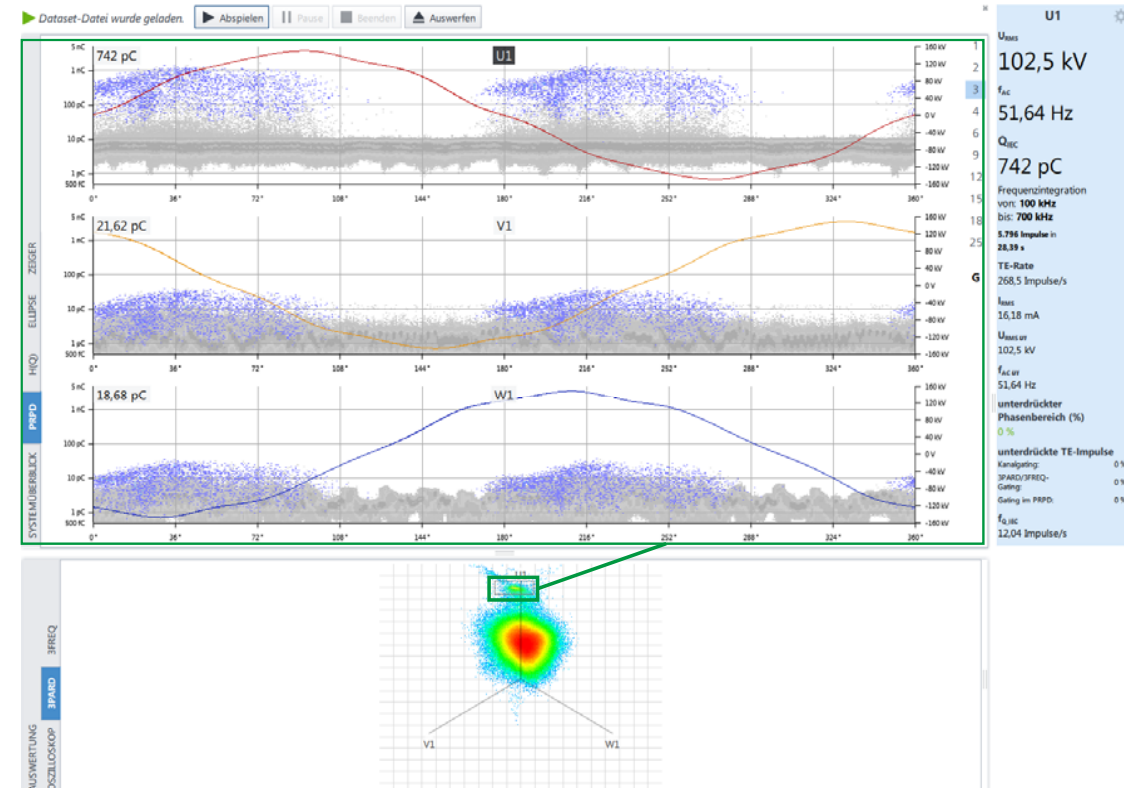
Assessment of PD Activity

- ▶ Time and frequency signal show high similarities to CAL signal
- ▶ Cross-coupling of real PD and CAL signal injected directly at the measuring tap are very similar

- ▶ **Conclusion:** PD source is close to measurement location

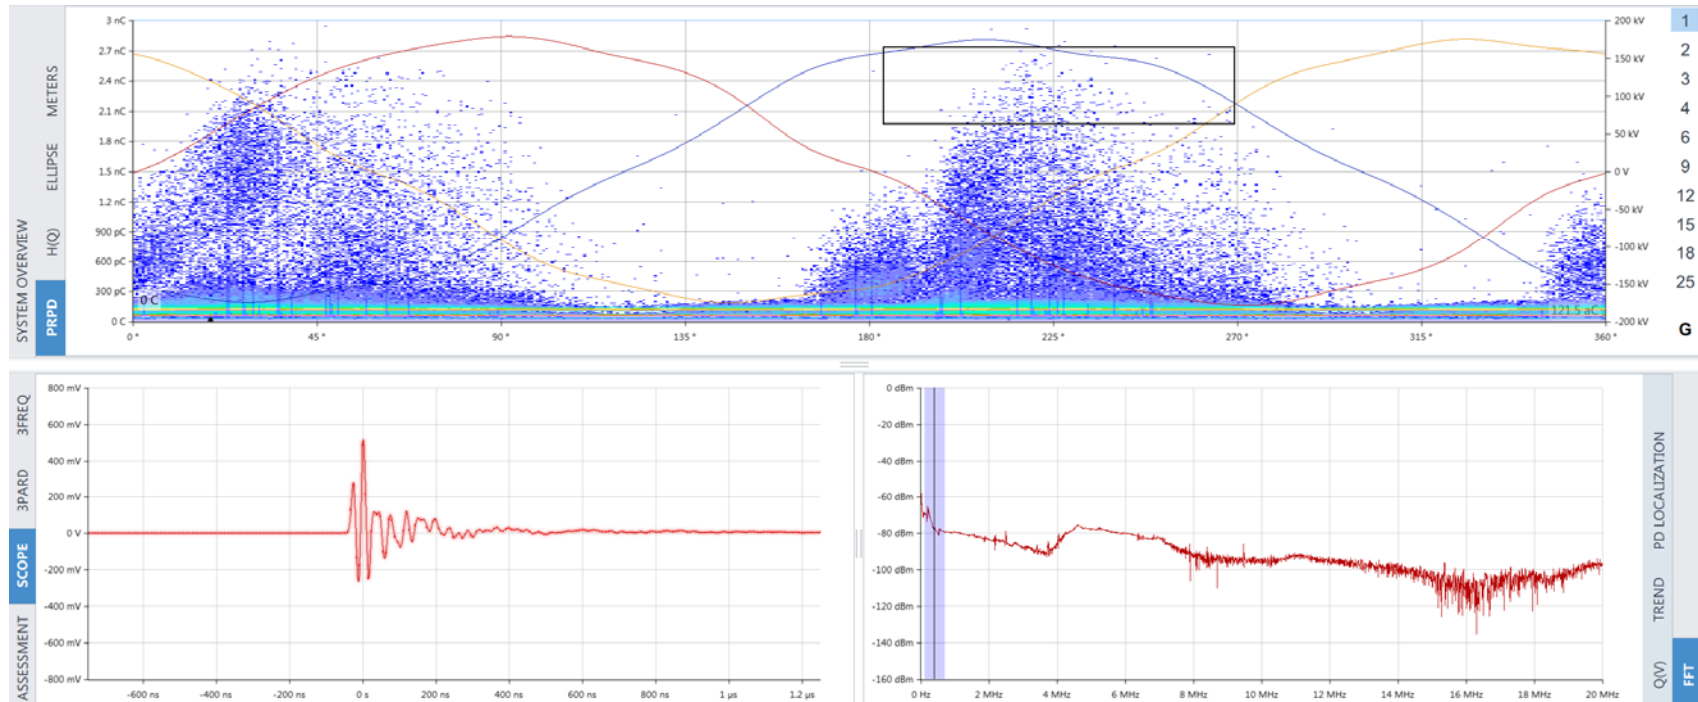
Assessment of PD Activity – Time Domain Signal

- ▶ Select single PD impulses via *Window Trigger*
- ▶ Analysis of impulse shape and frequency spectrum

Window-Trigger with corresponding time- and frequency domain signal

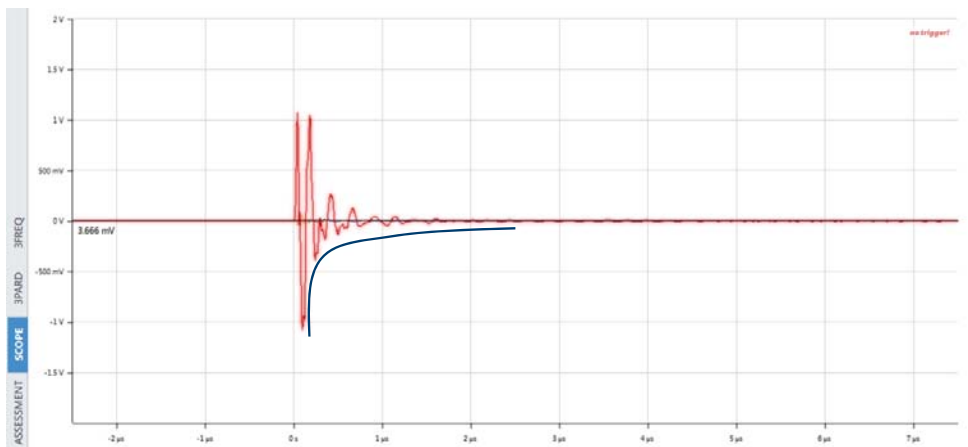
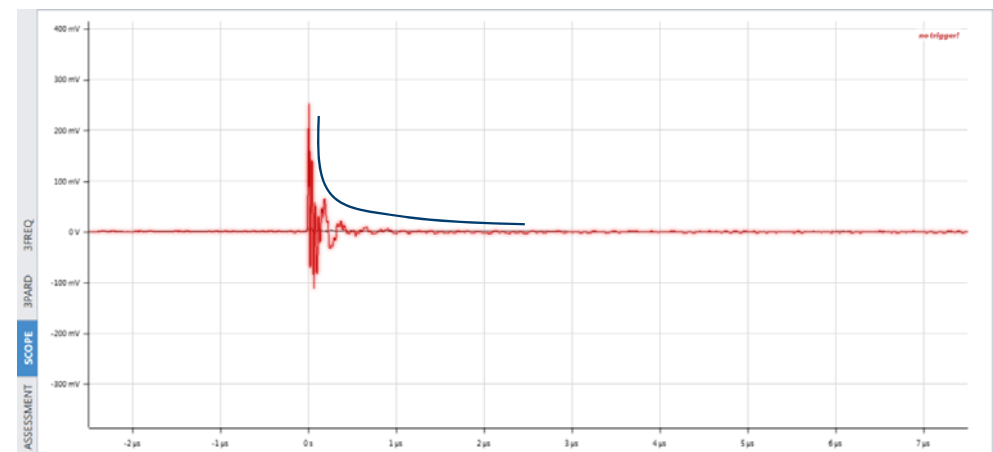
- Comparison of calibrator and PD impulse on phase 1U
- High-frequency impulse with little oscillations
- Indication for short propagation path
- **Conclusion:** PD source close measurement system, e.g. bushing.
- **Next step:** Acoustical PD localization

CAL at Channel 1U

PD at Channel 1U

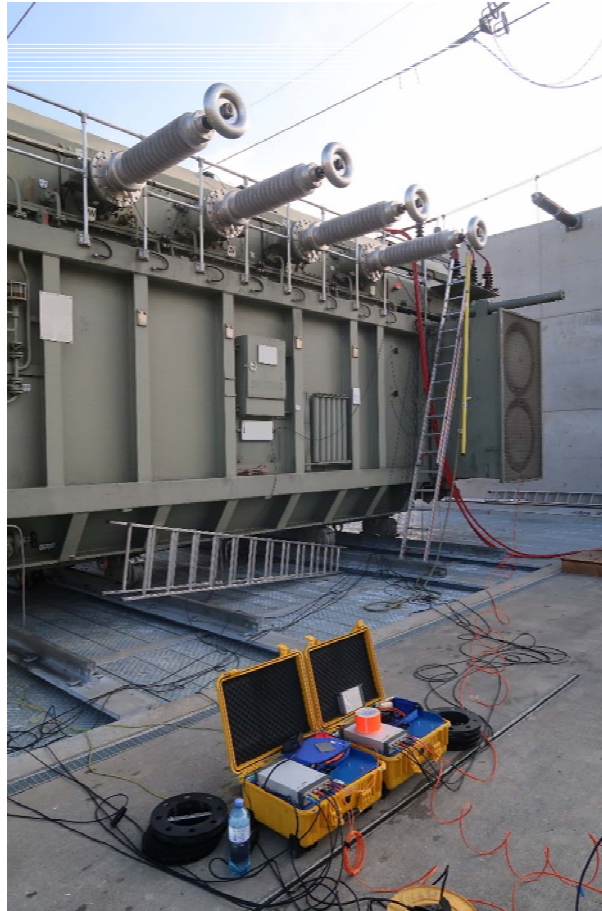
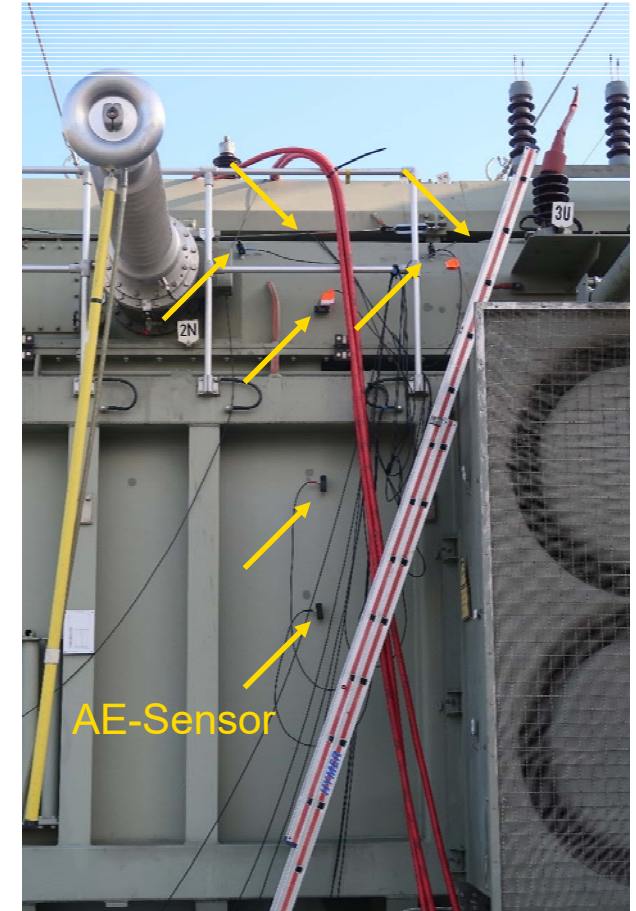
▶ Power Transformer – Acoustic PD Localization

- ▶ Two PDL 650 systems
 - ▶ 8 acoustic sensors/microphones
- ▶ Sensor position based on results of electrical PD measurement
- ▶ Sensitivity check via pencil tip
- ▶ Trigger
 - ▶ Electrical (using window trigger)
 - ▶ Acoustical

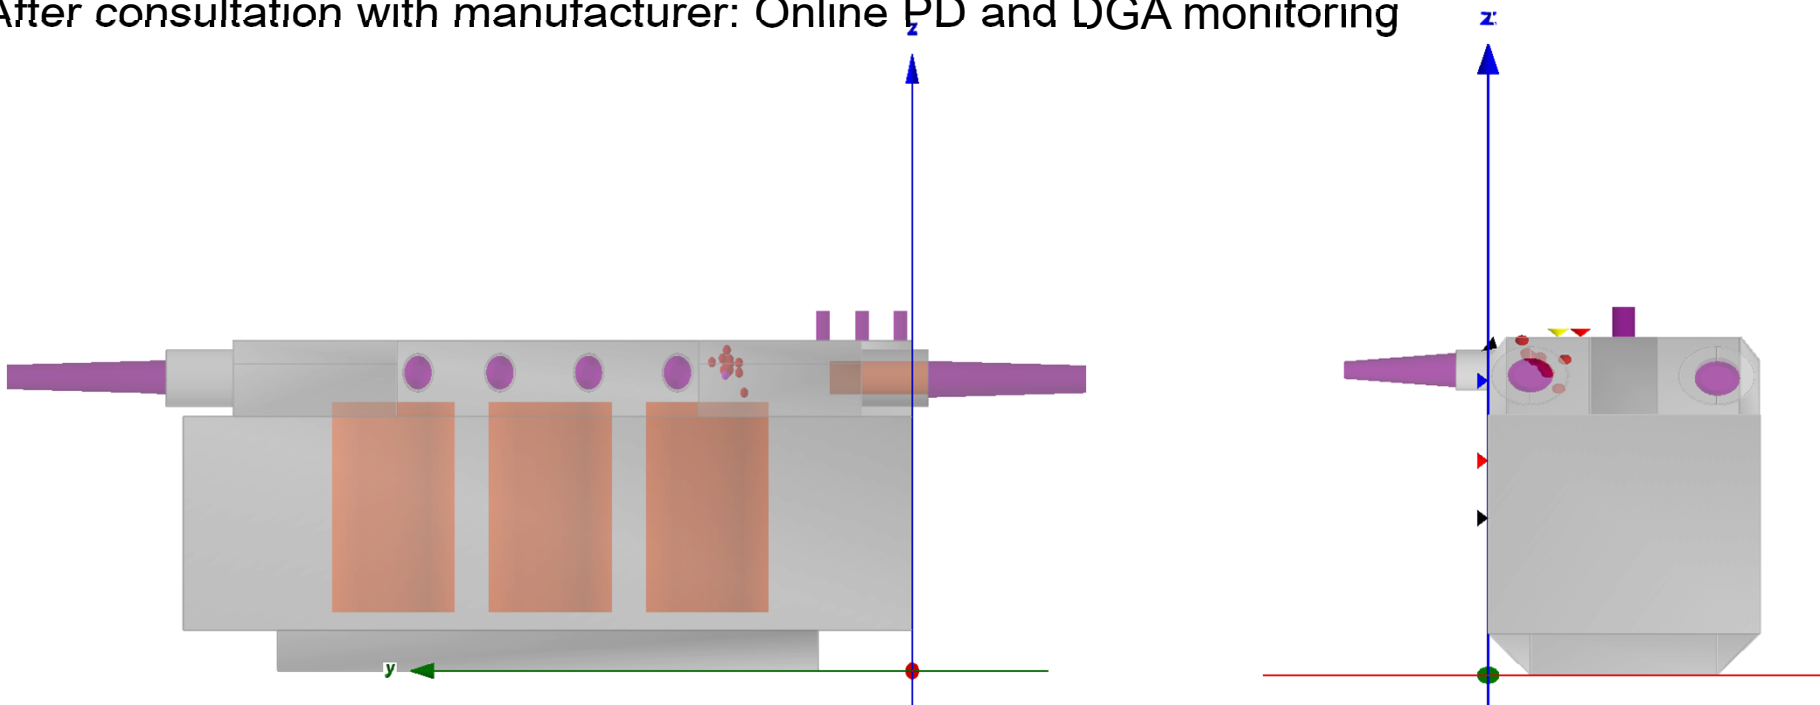
▶ Power Transformer – Acoustic PD Localization

- ▶ PD source close to winding connector of phase 1U
- ▶ Bushing seems not be affected
- ▶ On-site repair not feasible, transport to workshop too cost intensive
- ▶ After consultation with manufacturer: Online PD and DGA monitoring

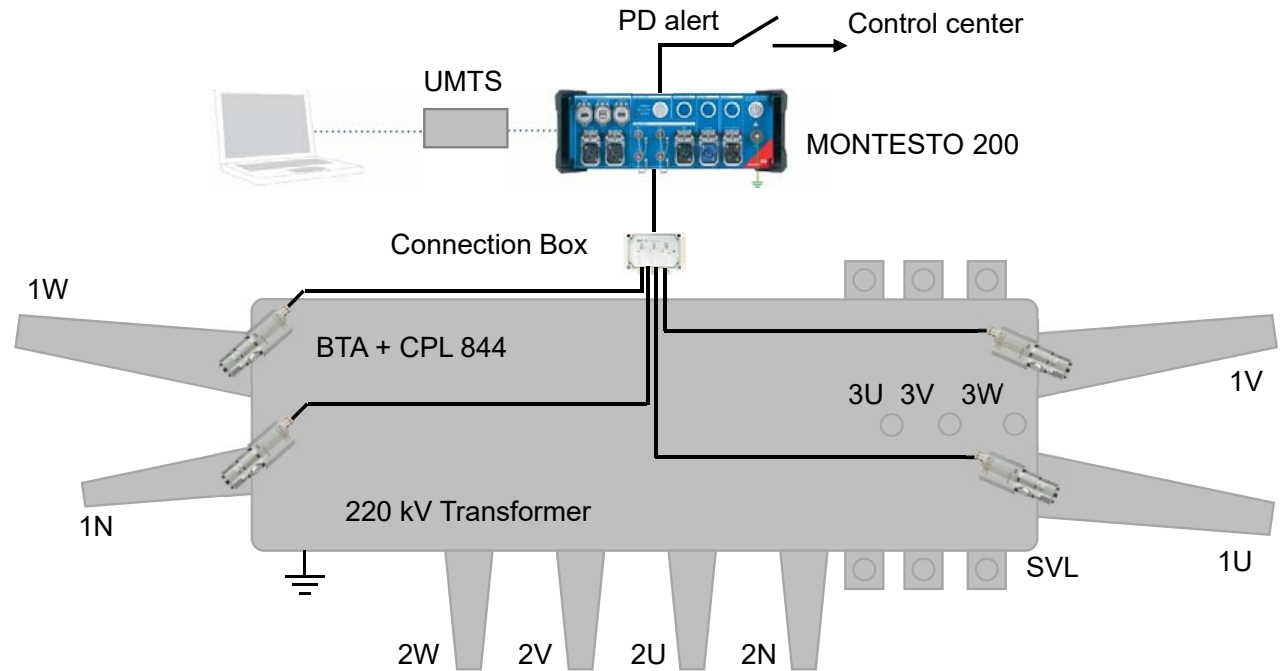
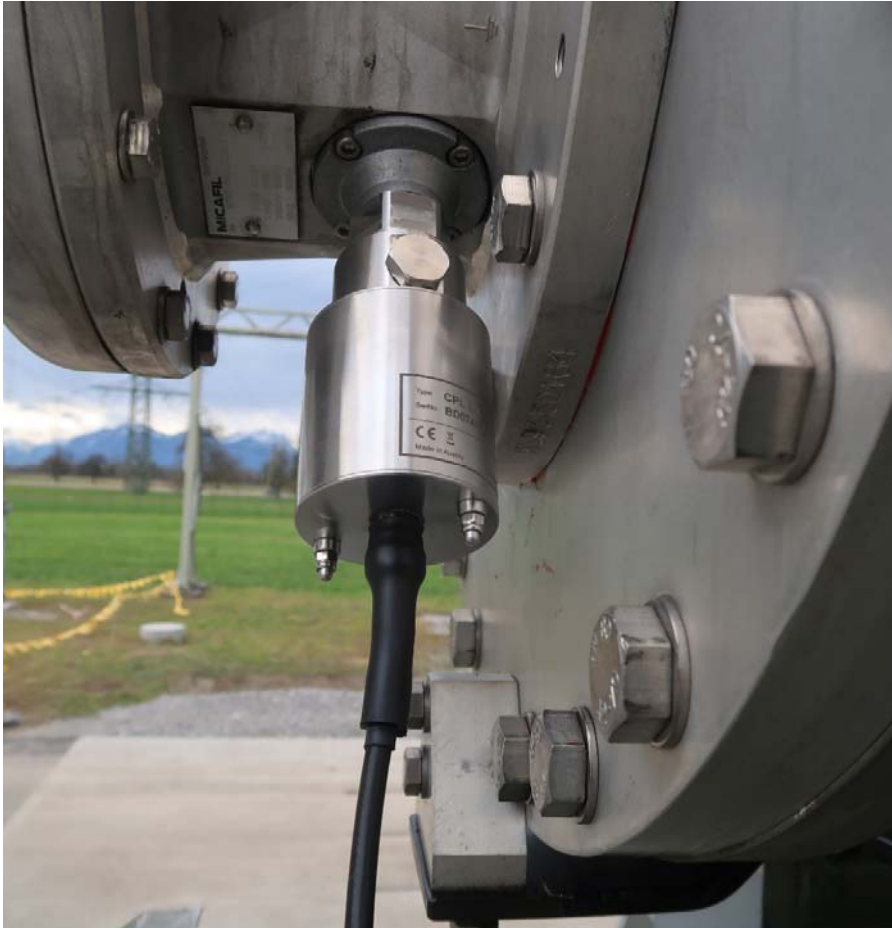
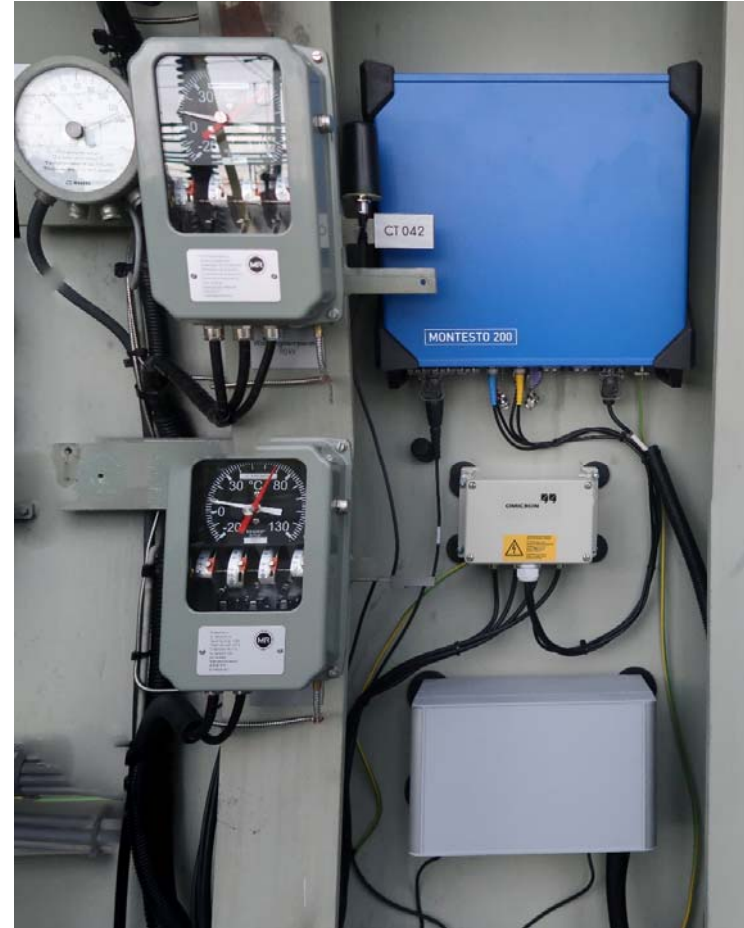
▶ Power Transformer – PD Trending Test Setup

- ▶ Measuring system **MONTESTO 200** with integrated IPC and 4 PD input channels is installed next to the connection box.
- ▶ Measuring impedance and bushing tap adapters are permanently installed at all 220 kV bushing taps (1U, 1V, 1W, 1N)
- ▶ Customized Solution:
 - ▶ UMTS modem for remote control
 - ▶ Automatic alert in control room by switching a contact in case of PD rule violation

Temporary PD Monitoring System

MONTESTO 200

Connection Box

UMTS Modem and contacts for PD alert

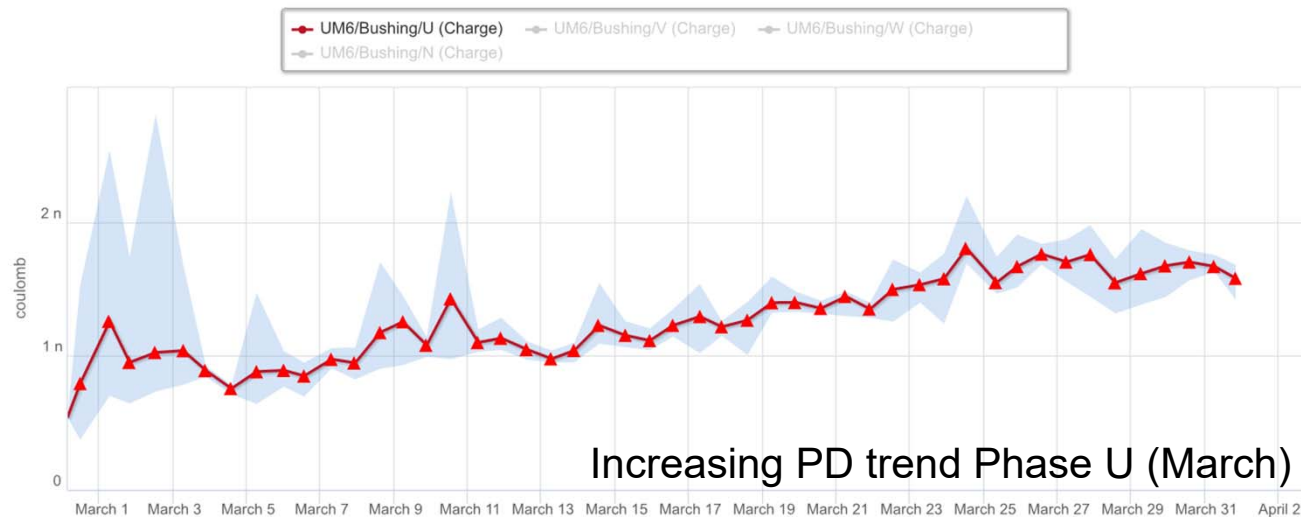
▶ Power Transformer – PD Trending

- ▶ Stable PD trend for the first two month (January / February)
 - ▷ approx. 500 pC on Phase U
- ▶ Increasing PD trend on Phase U over the period of 1 month (March)
 - ▷ afterwards the level stabilized ~ 1500 pC
- ▶ New PD source on Phase V after 4 month of operation
 - ▷ increasing trend for 3 month
 - ▷ afterwards the level stabilized at ~ 2000 pC

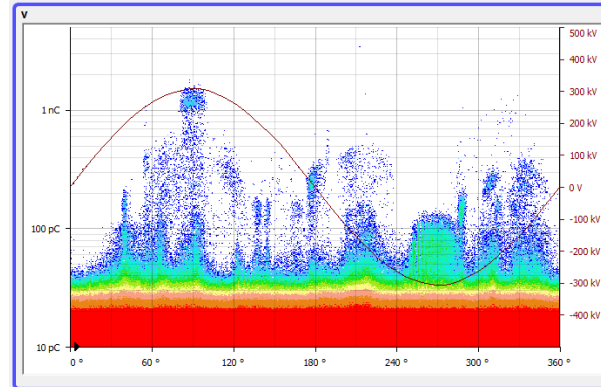
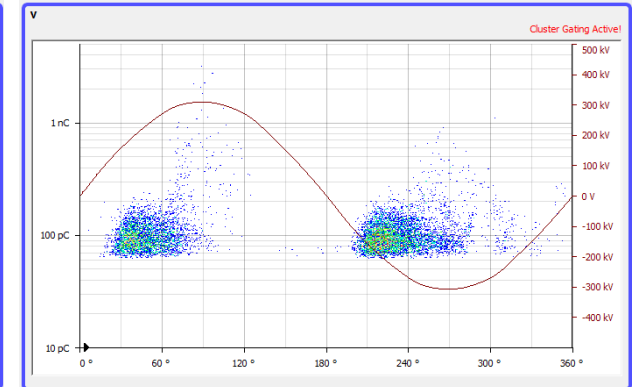
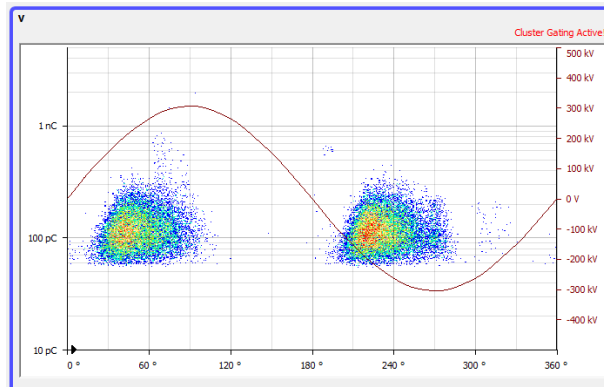
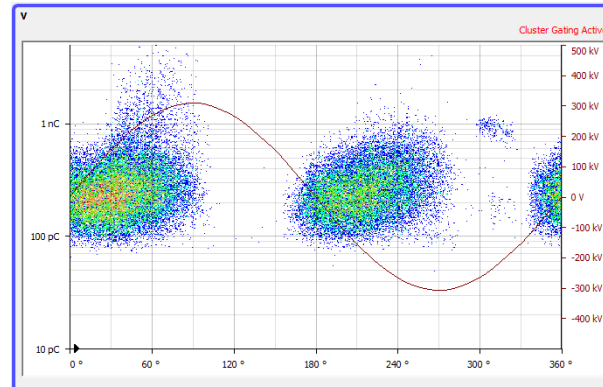
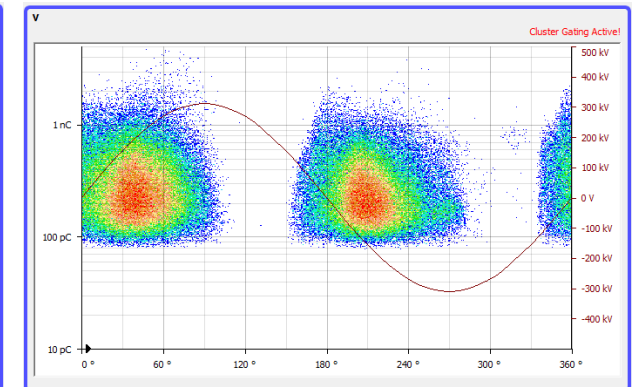
▶ Power Transformer – PD Trending

▶ Development of PD at Phase V

- ▶ First discharges end of March with 100 pC
- ▶ Increasing trend up to 2000 pC
- ▶ Stabilized after 3 months

29. February
(unfiltered, noise only)

27. March

21. April

08. May

03. June

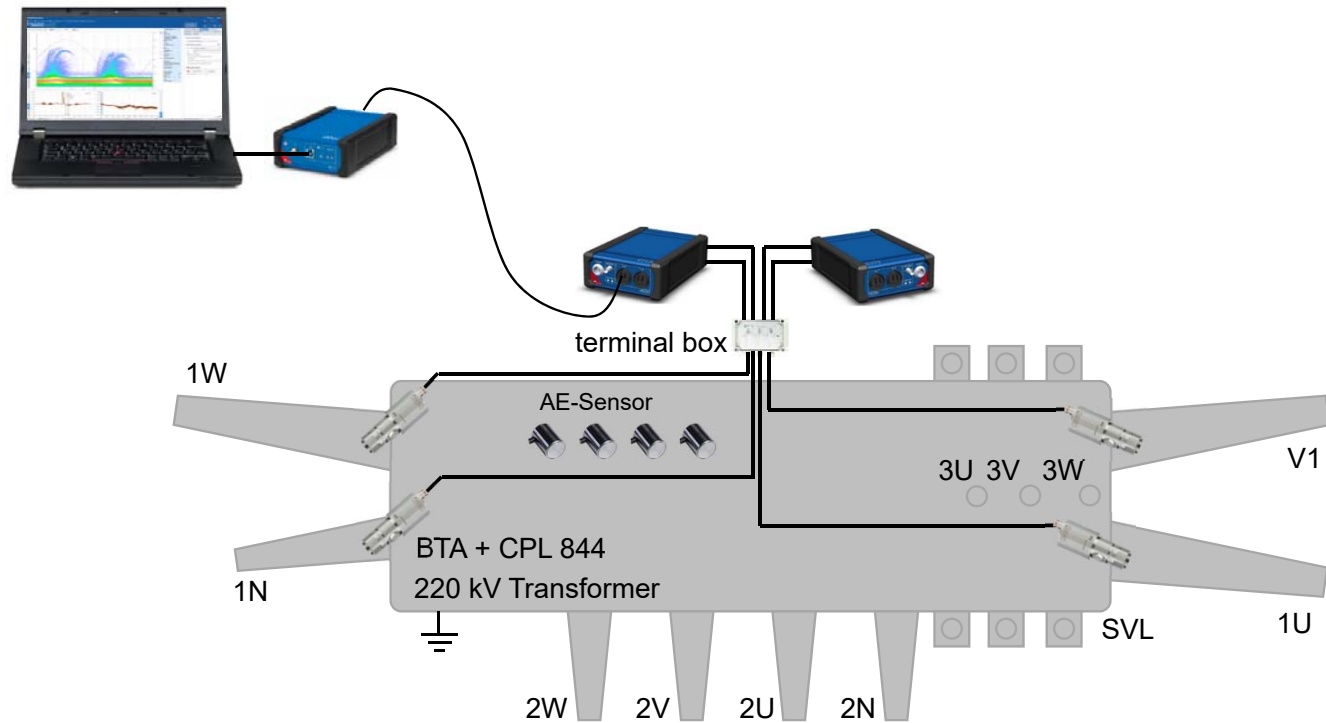
▶ Power Transformer – Online MPD 800 Test Setup

- ▶ Analysis and localization of the new developed PD pattern at Phase V using the MPD 800 - online
- ▶ Transformer can remain online for installation
- ▶ MPD 800 System directly connected to the pre-installed terminal box of the MONTESTO 200.
- ▶ PDL 650 used to pinpoint the acoustic signals.

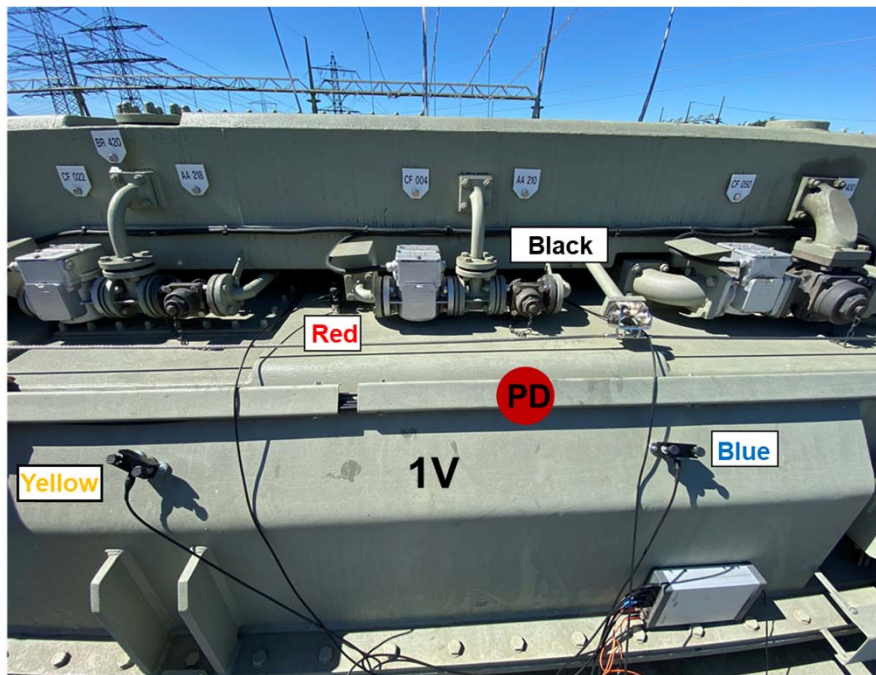
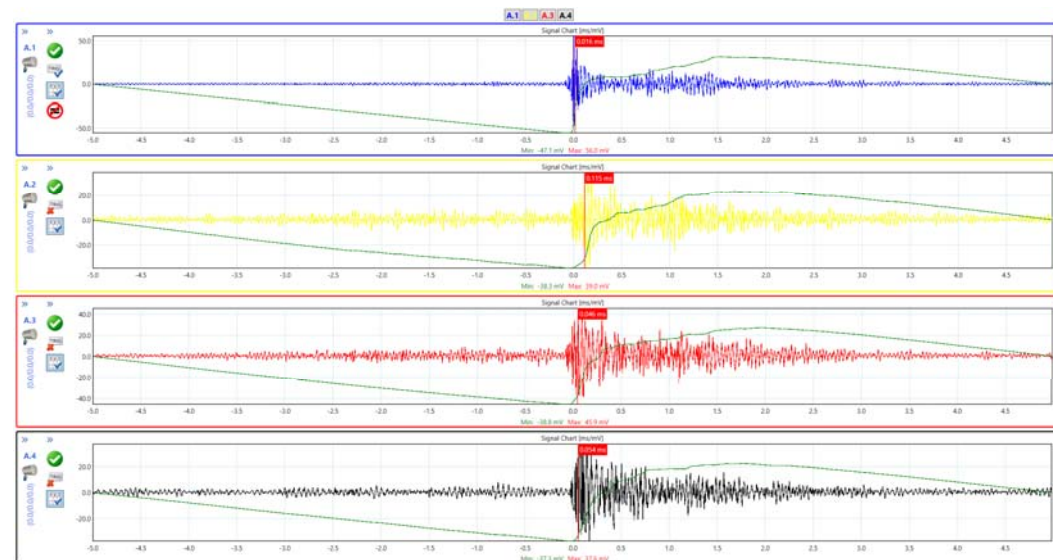
▶ Power Transformer – Online MPD 800 / PDL 650 Test

- ▶ PRPD Pattern at 1U and 1V look the same
- ▶ Time- and frequency domain signals of discharges at 1U and 1V show similarities
- ▶ PDL 650 detected acoustical signals at the exit lead of 1V
- ▶ **Conclusion:** It is very likely that PD happens at the same point at different windings!

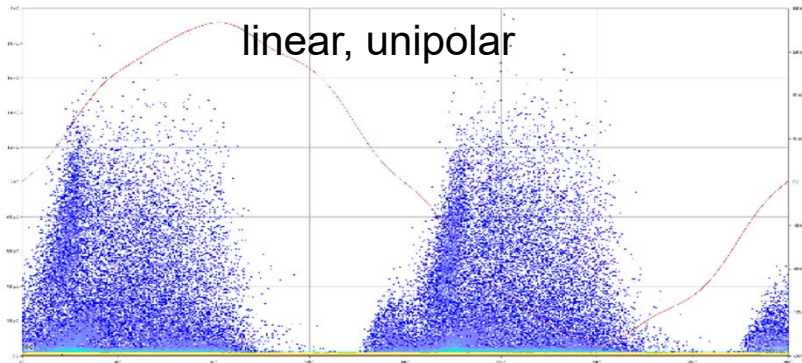
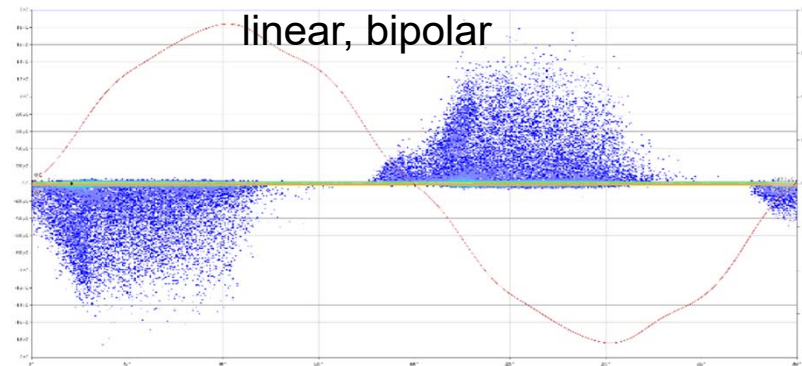
► Identification of PD Type

► PD at 1U at 0.72 x Un (91 kV)

► Comparison of measured PRPD pattern with “CIGRE Guide 676 – Partial Discharges in Transformers”

FLOATING VOID WITH INTERACTION AT THE SURFACE OF THE INSULATING MATERIAL

PD source	PD pattern	Remarks
		Voids with surface discharge
		Voids with surface discharge

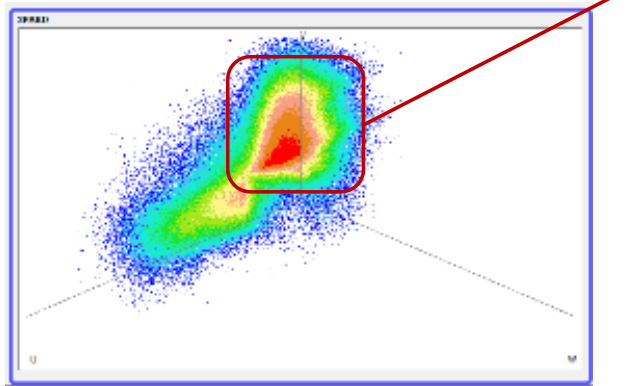
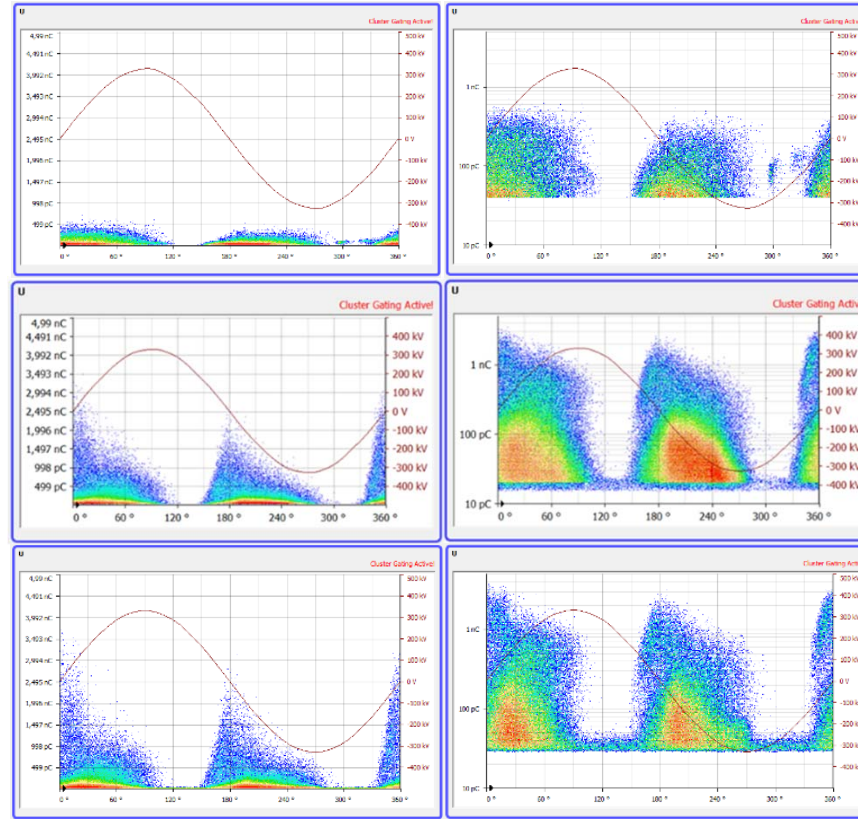
▶ Power Transformer – PD Trending

- ▶ Development of PD at Phase U
 - ▶ Started with 500 pC
 - ▶ Increase during a period of 1 month
 - ▶ Since then, it stabilized at 1500 pC

3PARD

PRPD Linear

PRPD Log

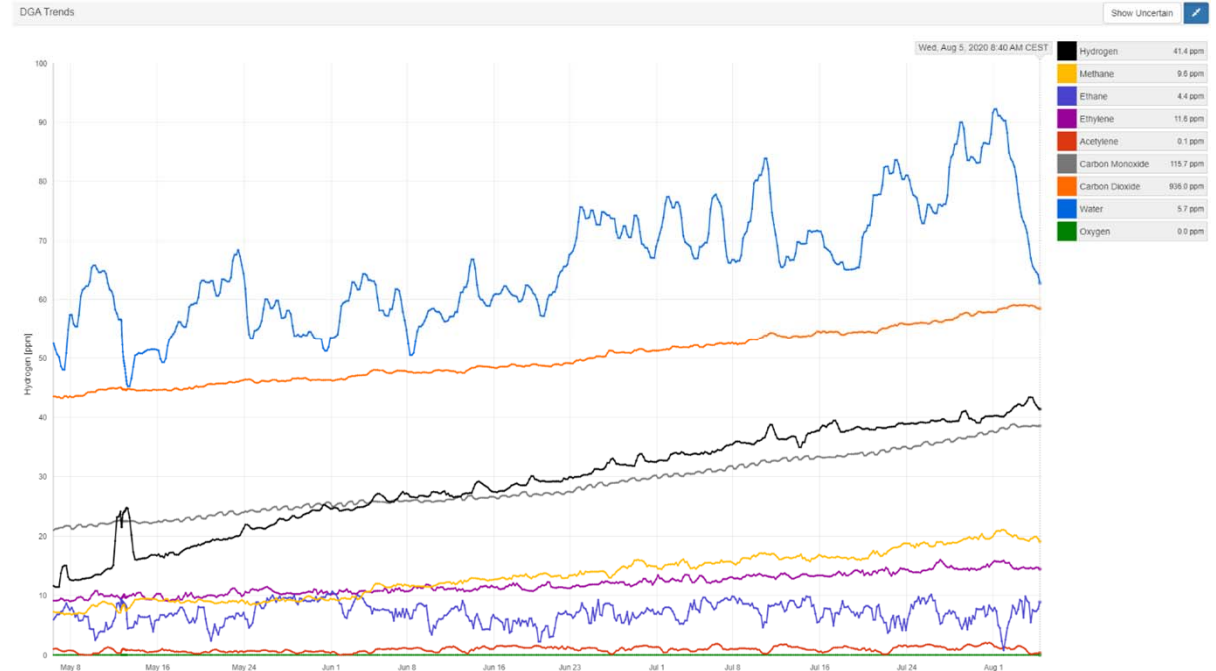
▶ Power Transformer – Dissolved Gas Analysis (DGA)

- ▶ DGA Monitoring of CAMLIN
- ▶ DGA results before and after transportation did not indicate any failure nor PD activity
- ▶ Hydrogen slightly increased during operation, but the overall amount of dissolved gases are below typical values, thus no reliable assessment can be performed according IEC 60599.
- ▶ A local defect inside a solid insulation part doesn't necessarily lead to an increase of dissolved gases.
- ▶ Electrical PD measurement and trending can be more sensitive and instantaneous compared to DGA
